P. RANACHOWSKI*, F. REJMUND*, Z. RANACHOWSKI*, A. PAWELEK**, A. PIĄTKOWSKI**, S. KUDELA JR***

MECHANOACOUSTIC AND MICROSCOPIC STUDY OF ALUMINOUS PORCELAIN RESISTANCE TO STRUCTURAL DEGRADATION

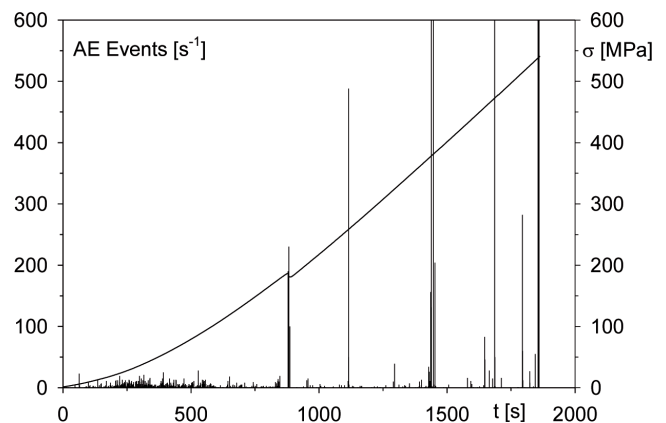
Fig. 2. Course of the rate of AE events versus increase of compressive stress for the tested sample, whose loading was stopped at 541 MPa, just before destruction. Only the preliminary and subcritical stages of degradation in stress range 0 ÷ 538 MPa are displayed. Strong signals of the last – critical stage are not included

with the typical strength of C 120 kind material – usually about 400 MPa. The obtained resistance was slightly lower than that of the weaker C 130 type porcelain (about 580 MPa). The relative dispersion of compressive strength was low and equalled 31.7%. Besides the damaged samples, a group of specimens was selected for the microscopic investigation. The compression process of these samples was stopped at different levels of stresses: 100, 250, 460, 521 and 541 MPa. Greater pieces of destroyed samples were also subjected to microscopic study. The applied procedure enabled a detailed study of degradation progress in the porcelain material, subjected to increasing load. The obtained mechanoacoustic characteristics of the particular samples showed considerable differentiation. Figure 2 presents course of the rate of AE events versus the increase of compressive stress for the sample, which loading was stopped at 541 MPa, just before the destruction. Figure 3 presents the energy of events in the interval of one second versus stress for the strongest specimen damaged at 608 MPa.

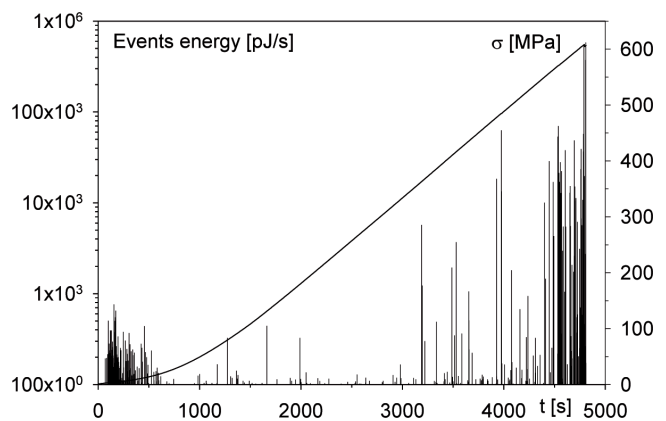
Fig. 3. Course of the energy of AE events in the interval of one second (pJ/s) versus stress for the strongest sample damaged at 608 MPa. There was applied logarithmic scale for AE descriptor

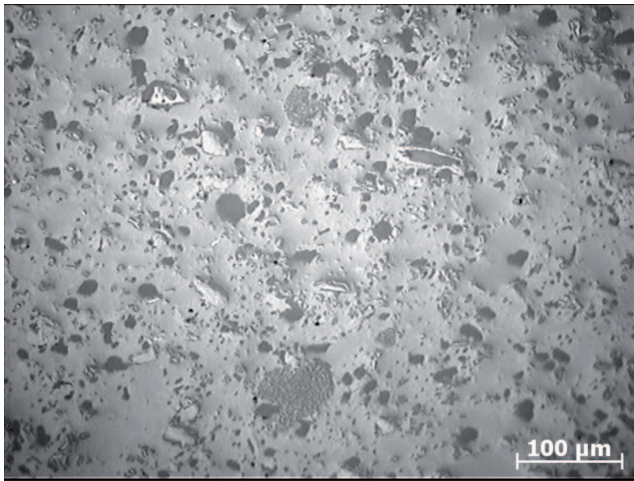
Fig. 6. Image of the structure at central part of the sample stressed up to 521 MPa, magnification 200x. Black areas remaining after crushed out particles of cullet and quartz grains constitute above 8% of surface. Strongly cracked, great and dark precipitates of mullite are visible. Quartz grain contains peripheral and internal cracks. Damages of corundum phase are rare

The second – subcritical stage of structure degradation is closely connected with the homogeneity of the sample structure in micro and semi-macro scales. The subcritical stage follows the preliminary stage and lasts to the beginning of the critical stage. This phase of destruction is considerably varied for particular samples and shows single or series of acoustic signals of low or moderate intensity of AE activity. Intervals of longer AE activity occurred rarely. The strongest signals follow the fracture and splitting off the walls and corners from the sample. During this period further damage of particles of cullet (without acoustic effects) and quartz grains (weak AE signals) takes place. There are created peripheral and internal cracks in grains. A slow degradation of mullite phase was registered too. The stresses of advanced subcritical stage, especially in the central section of the samples, caused initiation of internal cracks and sometimes crushing out parts of precipitates. They were strongly bounded with the glassy matrix and peripheral cracks occurred very rarely. In the case of the samples, which were stressed up to the end of subcritical stage (460 and 521 MPa), the area of damaged, separated and crushed out elements of structure comprised about 8% of surface. This value included almost the whole cullet (below 5%), a part of quartz grains (especially of small size) and less than 1% of mullite phase. Figure 5 presents the structure of the sample containing moderate effects of subcritical degradation. In Figure 6 strongly advanced subcritical effects, in the central part of the sample compressed up to 521 MPa, are visible.
